Reserve Study Report

Level I Full With-Site-Visit Study

Kawela Plantation HA

Report	# 3001-3
Prepared	July 24, 2018
Fiscal Year	January 1, 2018 through December 31, 2018
Report Expires	December 31, 2018

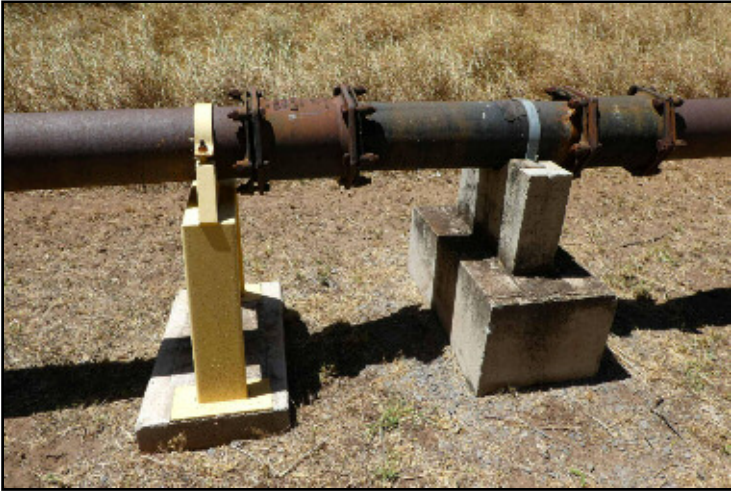
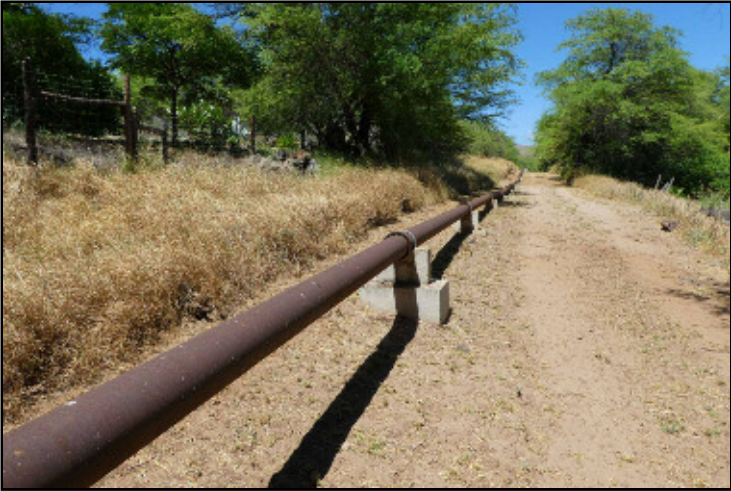
Component:	206 - Crossover Concrete Pillars - Replace/Repair	Quantity:	Minimal
Location:	Crossover concrete pillars		
Cost Source:	Estimate provided by client	Useful Life:	10
Best Case:	\$12,000 Estimate for repair	Remaining Useful Life:	6
Worst Case:	\$13,500 Higher estimate

Evaluation: Small in house repairs were performed in 2017. Reported future repairs will be required.

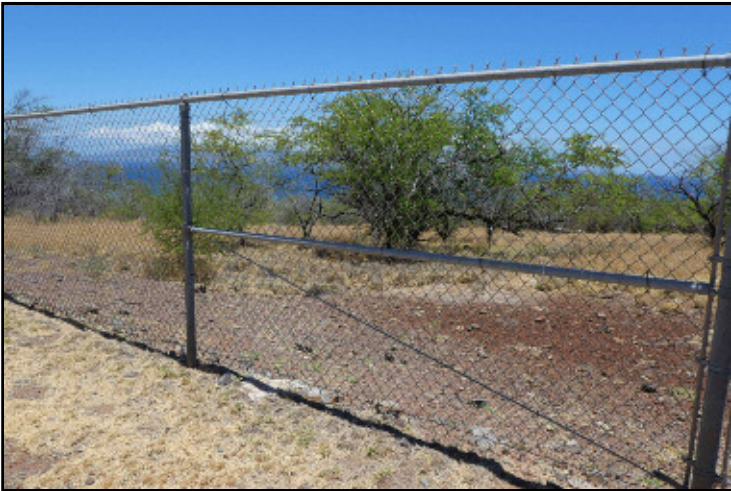
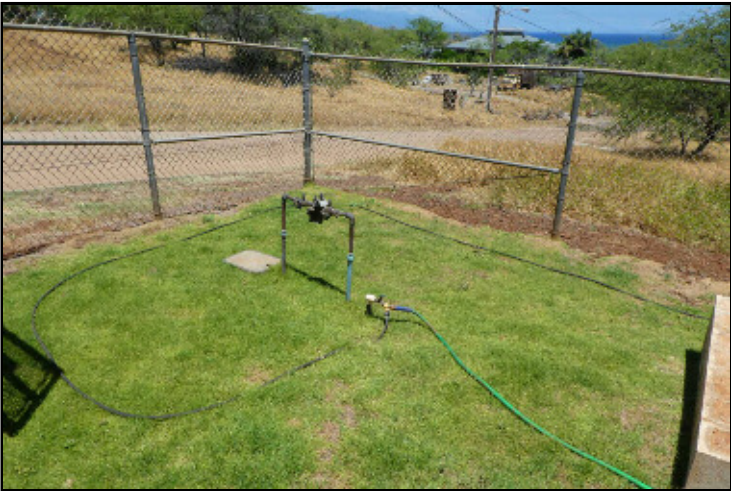
Component:	309 - Chain Link Fencing - Replace	Quantity:	Approx 4,400 LF
Location:			
Cost Source:		Useful Life:	
Best Case:		Remaining Useful Life:	
Worst Case:

Evaluation: Standard 7 Ft tall galvanized fencing supported by tubular framework. Most sections undamaged and secure. Hinged gates function and most are in alignment. Generally in fair condition, aging extended due to dry climate. Expect to repair as needed under the Operating Budget, not Reserves.

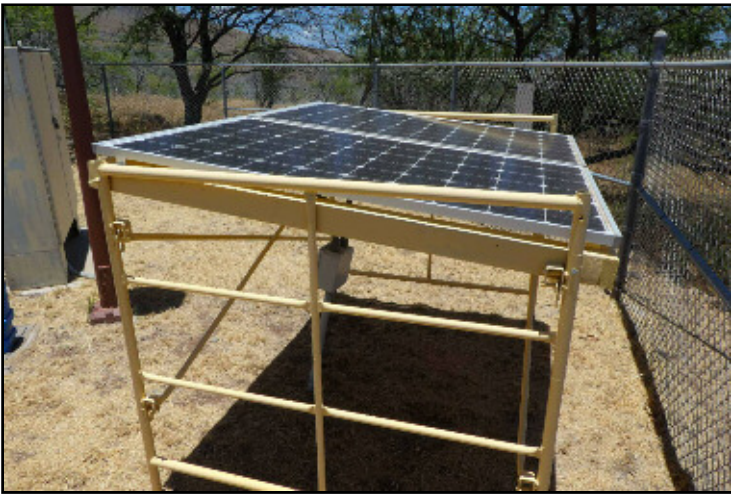
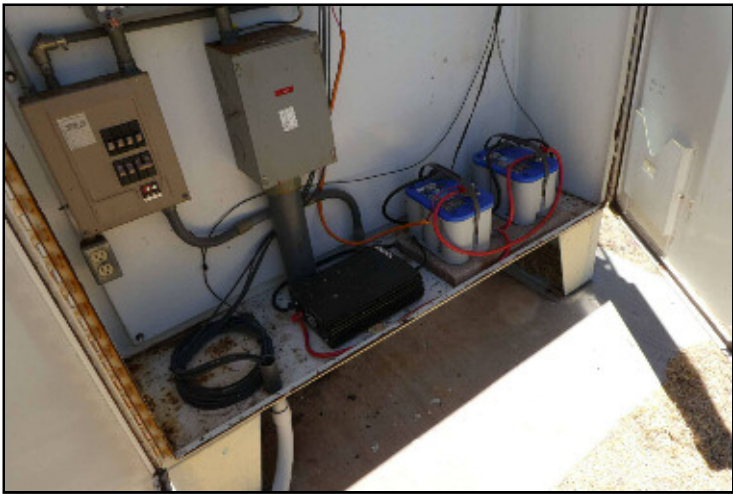
Component: 433 - Solar Panels - Replace
Location: Tank and PRV Stations
Cost Source: Client Cost History
Best Case: \$7,500 Estimate to replace
Worst Case: \$10,000 Higher estimate

Evaluation: PV systems installed in 2014. System is in fair functional condition with no problems reported.

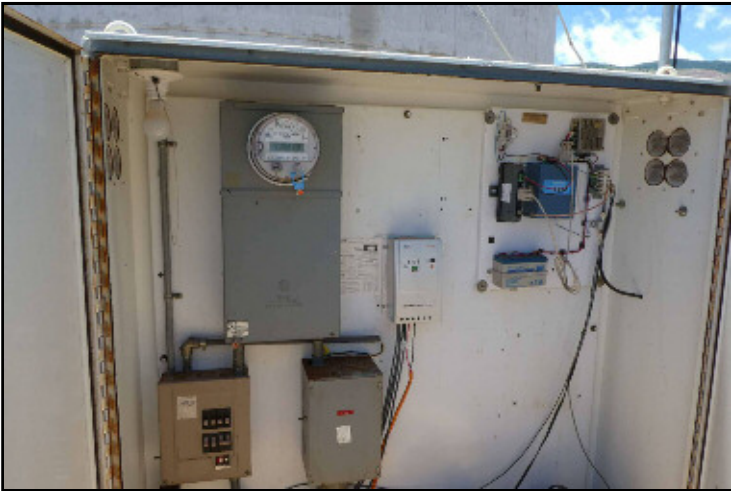
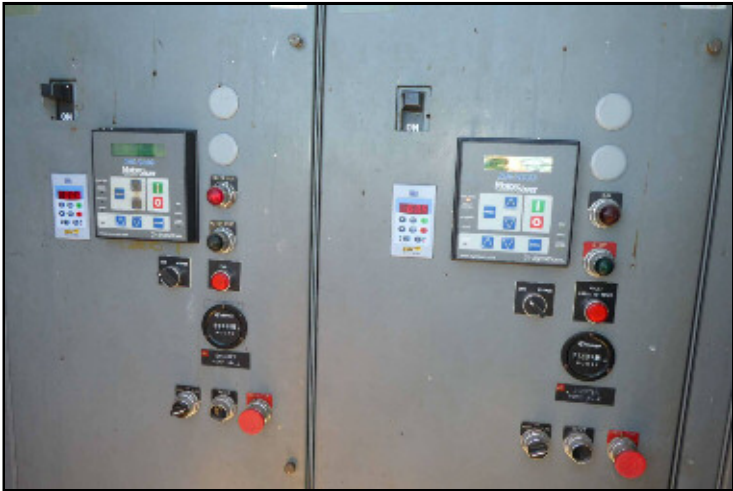
Component: 447 - Telemetry - Motor Controls - Replace
Location: DW electrical cabinets
Cost Source: Client Cost History
Best Case: \$15,000 Estimate to replace
Worst Case: \$15,000 Higher estimate for upgraded components

Evaluation: PLC (Program Logic Center) control the motors more efficiently with the HMI Telemetry System. Upgrade to run on newer OS.

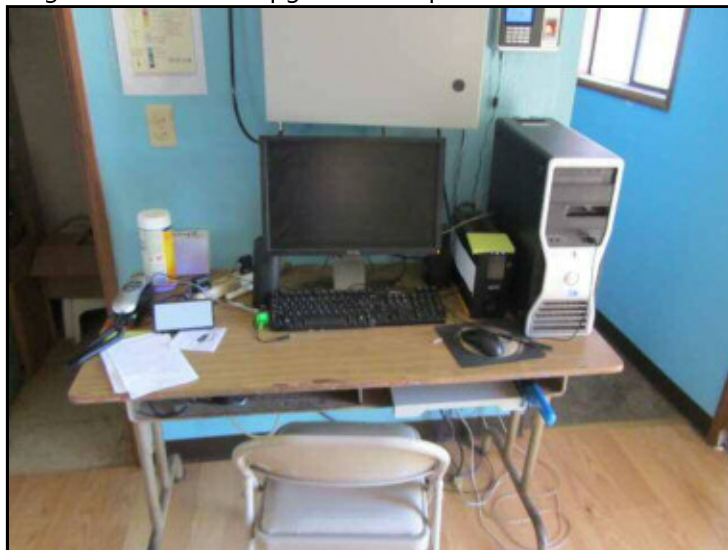
Component: 447 - Telemetry SCADA - Replace
Location: Telemetry Control Computer in Office

Evaluation: Reported SCADA system and computer will be replaced in 2018.

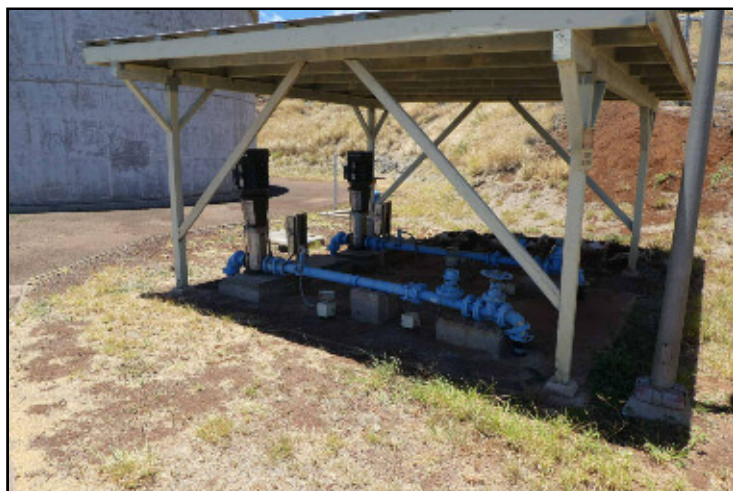
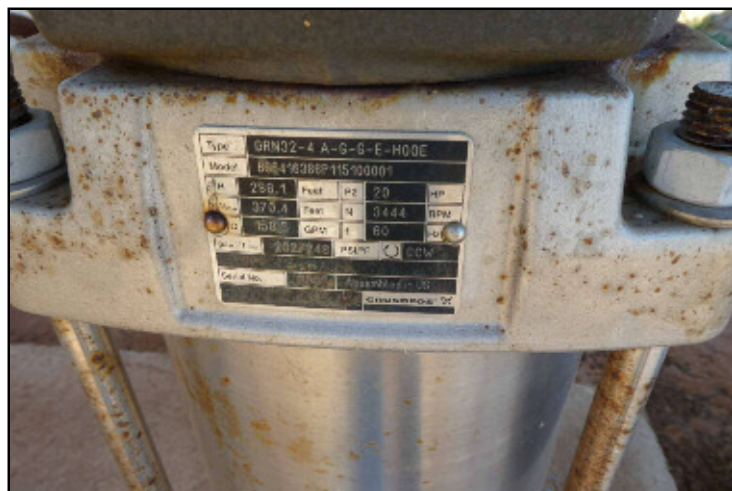
Component: 472 - Dom. Water Booster Pump #1 -Replace

Evaluation: Replaced 15 HP Grundfos "cam" pump in 2015. Expect eventual replacement of pump, flow meter and gate valve on this cycle.

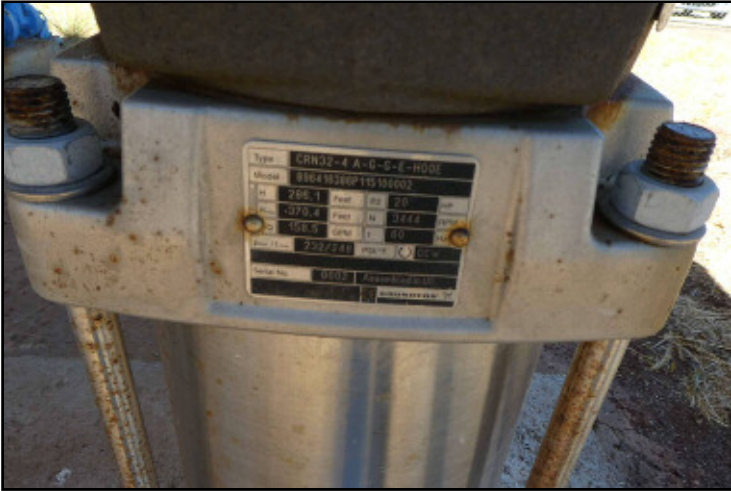
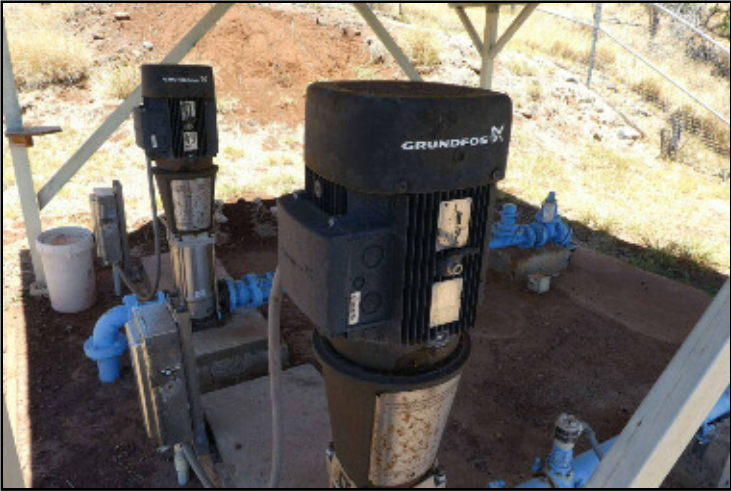
Component:	472 - Dom. Water Booster Pump #2 -Replace	Quantity:	(1) 15 HP Cam Pump
Location:	Site #1		
Cost Source:	Akamai Reserves Cost Database	Useful Life:	10 Remaining Useful Life:7
Best Case:	\$17,000	Estimate to replace 15 HP Pump & VSD	
Worst Case:	\$19,000	Higher estimate

Evaluation: Replaced 15 HP Grundfos "cam" pump in 2015. Expect eventual replacement of pump, flow meter and gate valve on this cycle. Coordinate with Booster Pump #1 Replacement. Both boosters pump from DT 100,000 USG tank #1 to DT 150,000 USG tank #2.

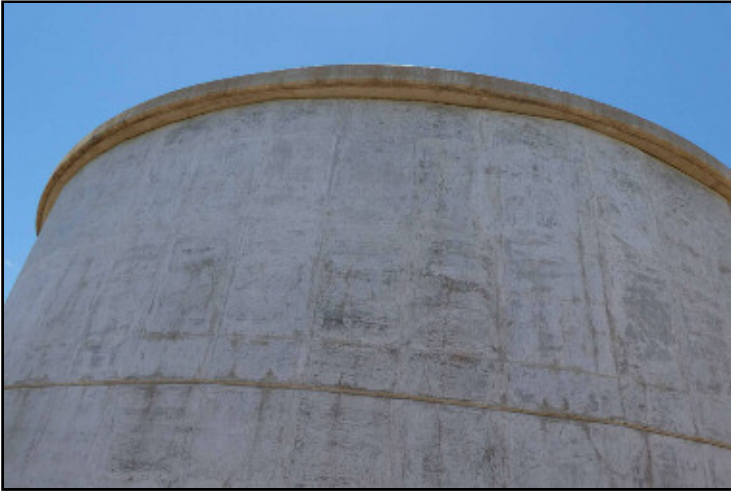
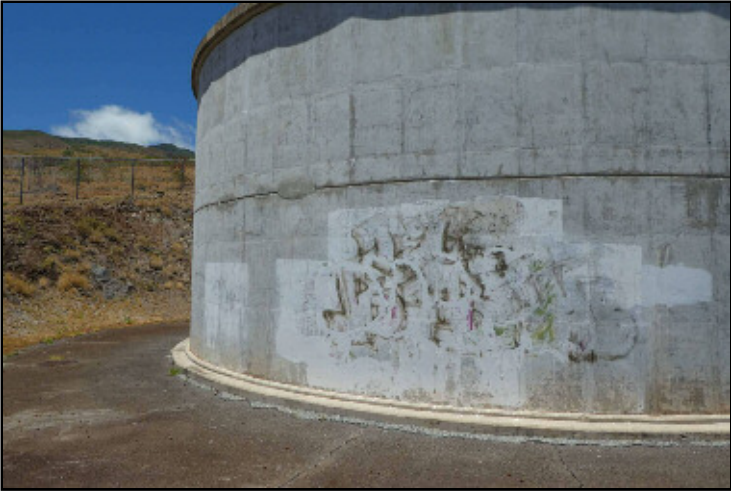
Evaluation: Water tanks were opened and inspected in 2015. Expect future inspections on this cycle.

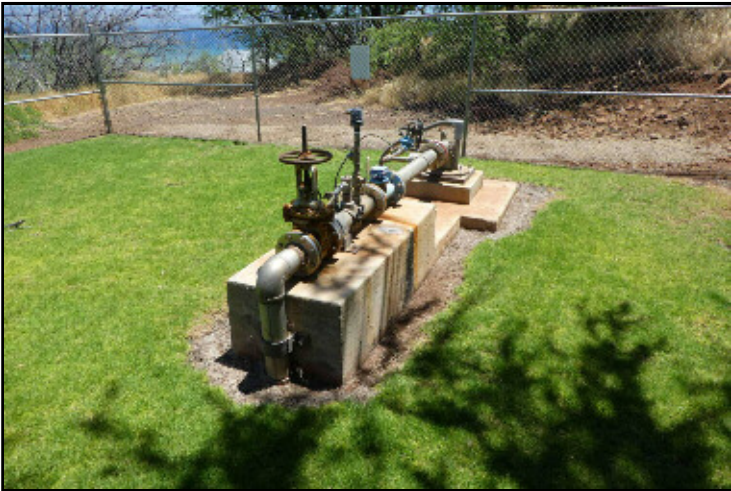
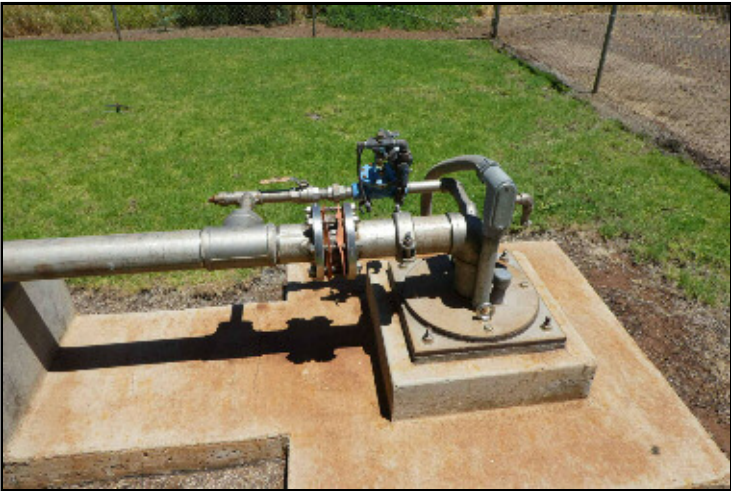
Component: 680 - DW #2A Well Pump & Valve - Replace
Location: Site #3
Cost Source: Client Cost History
Best Case: \$75,000 Lower estimate for replacement pump/valve - installed
Worst Case: \$80,000 Higher estimate

Evaluation: Multi-staged submersible pump was last replaced in 2010. Reported to be in fair functional condition.

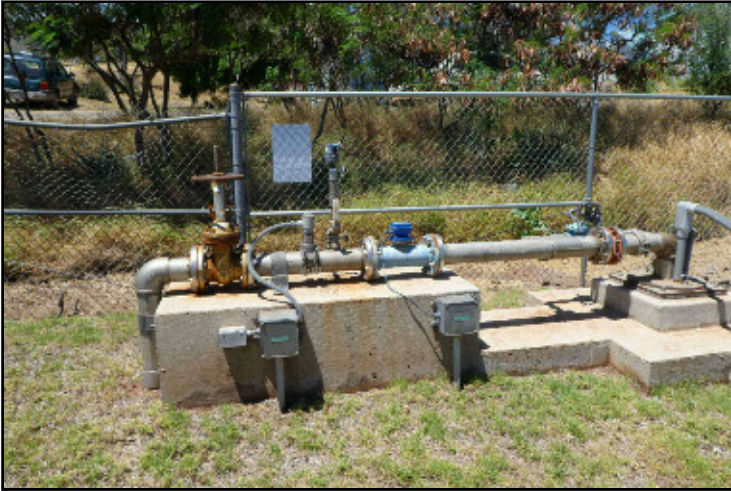
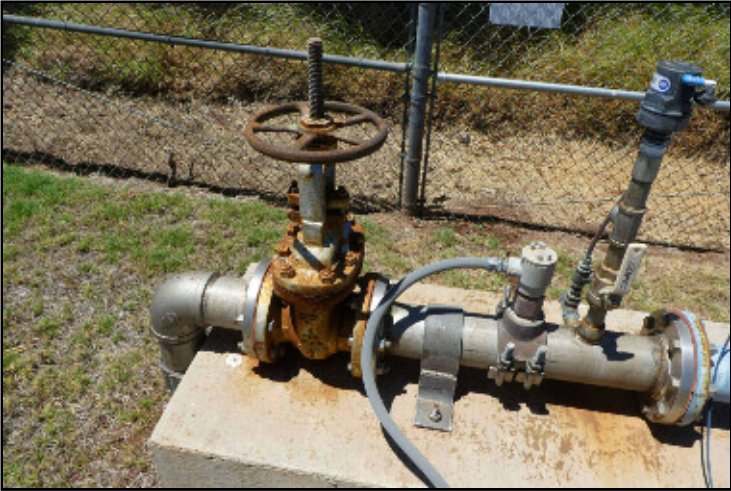
Component:	680 - DW #3A Well Pump & Valve - Replace	Quantity:	(1) 15 HP Multi Stage
Location:	Site #4		
Cost Source:	Client Cost History	Useful Life:	8 Remaining Useful Life:
Best Case:	\$75,000		Lower estimate for replacement pump/valve - installed
Worst Case:	\$80,000		Higher estimate

Evaluation: Multi-staged submersible pump was last replaced in 2010. Reported to be in fair functional condition.

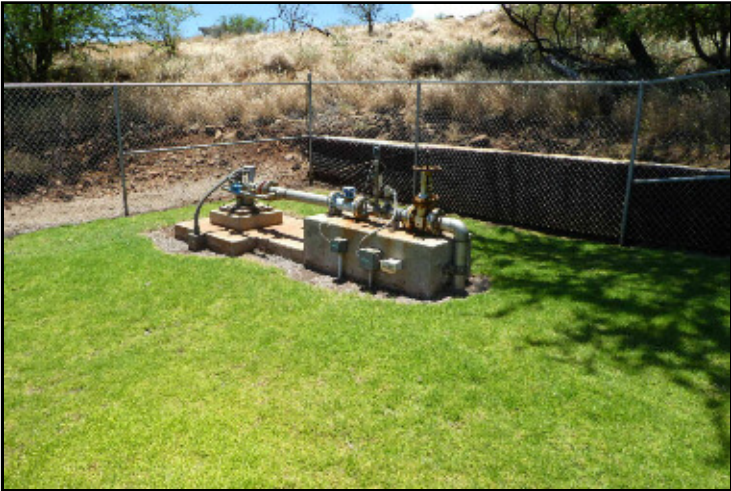
Component:	681 - DW #2 Well Casing - Replace	Quantity:	Approx 235 LF
Location:	Site #3		
Cost Source:	Client Cost History	Useful Life:	30 Remaining Useful Life:
Best Case:	\$170,000		Estimate to replace
Worst Case:	\$180,000		Higher estimate

Evaluation: Well casing was replaced in 2010. This is a long life component replacement may be deferred based on future condition.

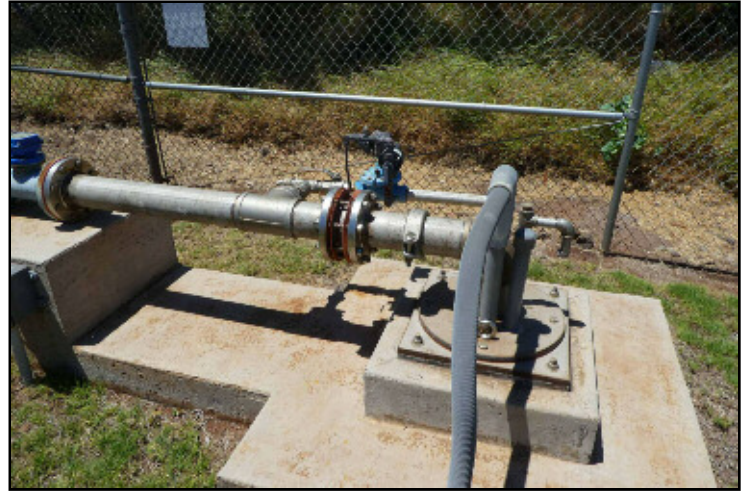
Evaluation: Well casing was replaced in 2009. This is a long life component replacement may be deferred based on future condition.

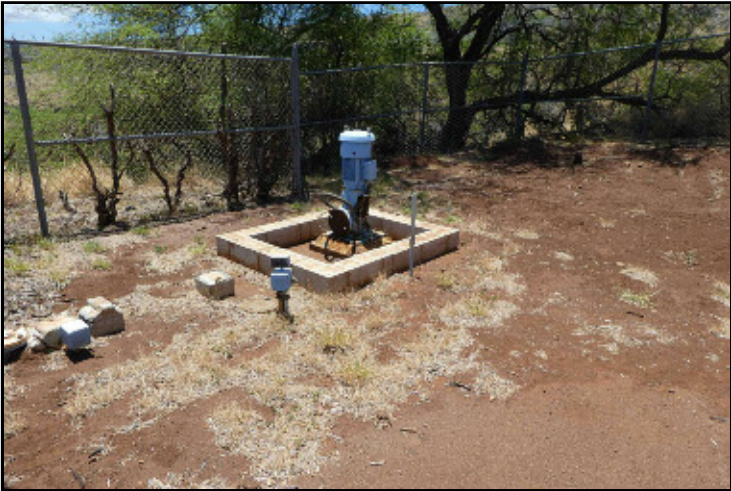
Component:	685 - Old Well Pumps - Decommission	Quantity:	(4) Well Sites
Location:	Well sites		
Cost Source:	Estimate provided by client	Useful Life:	Remaining Useful Life:5
Best Case:	\$150,000	Estimate to remove pumps and fill wells	
Worst Case:	\$175,000	Higher estimate

Evaluation: Old wells may require equipment removal and fill. This is a planned one time expense.

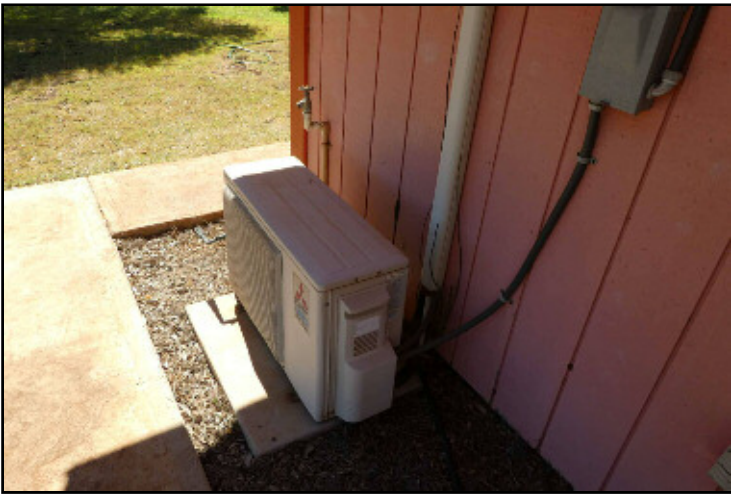
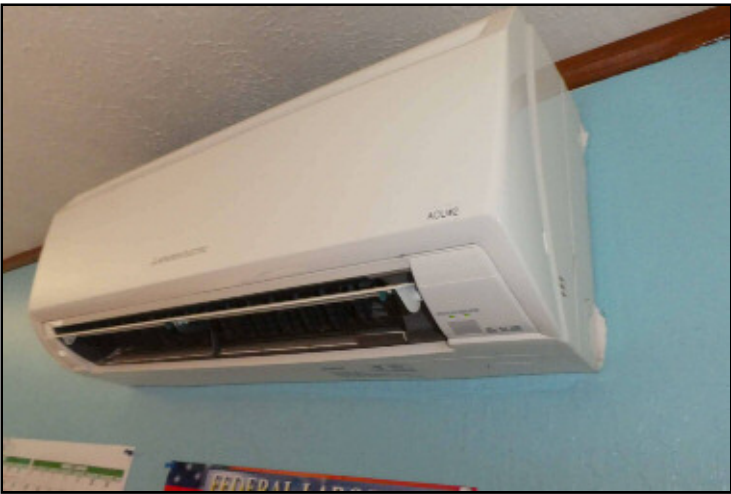
Component: 435 - HVAC - Replace
Location: Office Building
Cost Source: Akamai Reserves Cost Database
Best Case: \$7,000 Estimate for replace
Worst Case: \$9,000 Higher estimate

Evaluation: Air conditioner is functional and in fair condition. Reported office AC unit has leaked and requires annual cleaning.

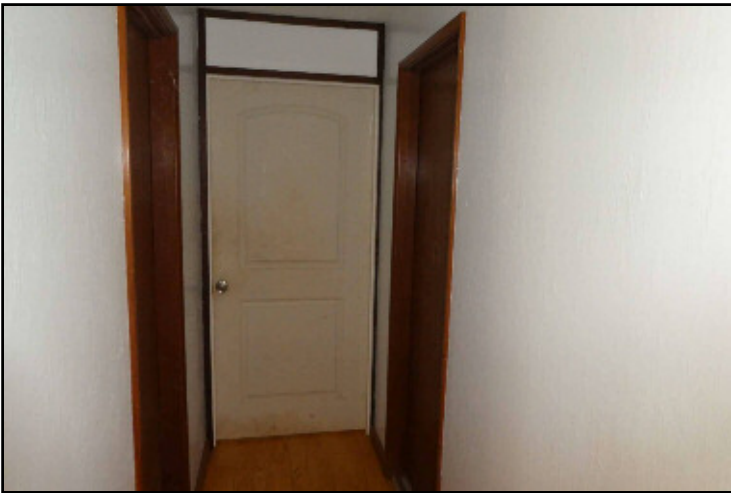
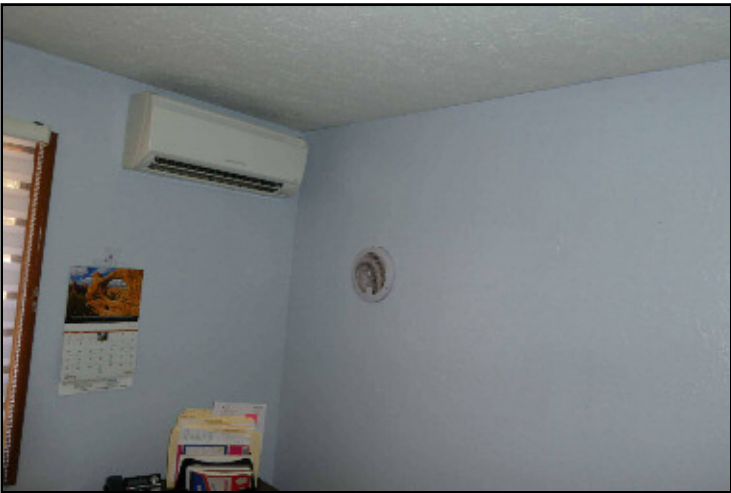
Component: 701 - Interior Surfaces - Paint
Location: Interior of Office/Club House Building
Cost Source: Akamai Reserves Cost Database
Best Case: \$2,916 \$0.90/GSF; Estimate to paint with patching
Worst Case: \$4,050 \$1.25/GSF; Higher estimate for more patching

Evaluation: Interior surfaces are in fair attractive condition.

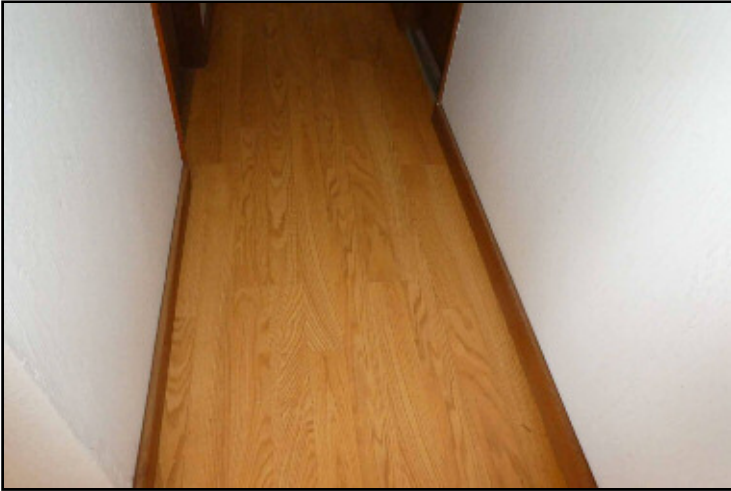
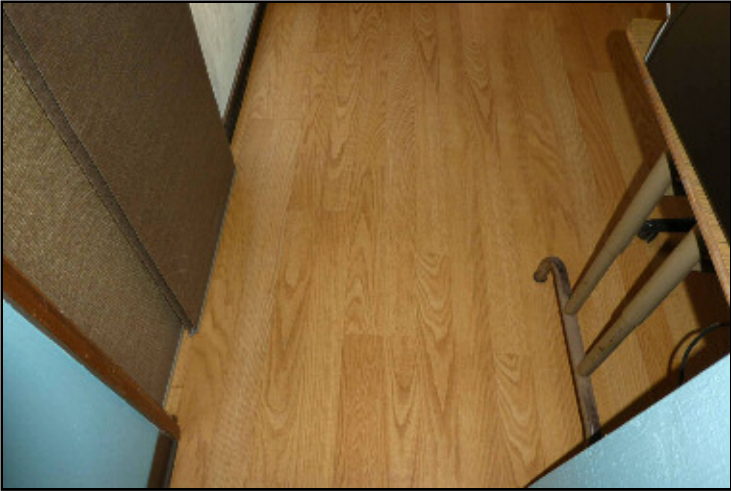
Component: 708 - Wood Flooring - Replace
Location: Office Building
Cost Source: Client Cost History
Best Case: \$5,100 Estimate to replace
Worst Case: \$7,650 Higher estimate

Evaluation: Office flooring is in fair attractive condition.

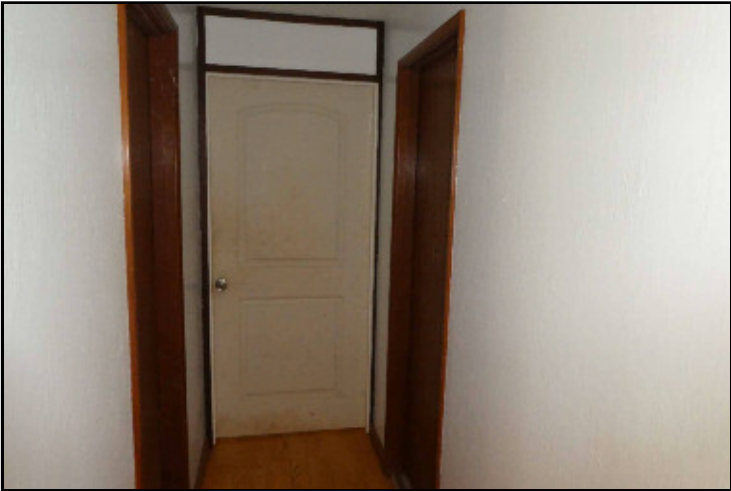
Evaluation: Doors are aged and in fair to poor condition. Recommend partial replacement of 2 doors on this cycle.

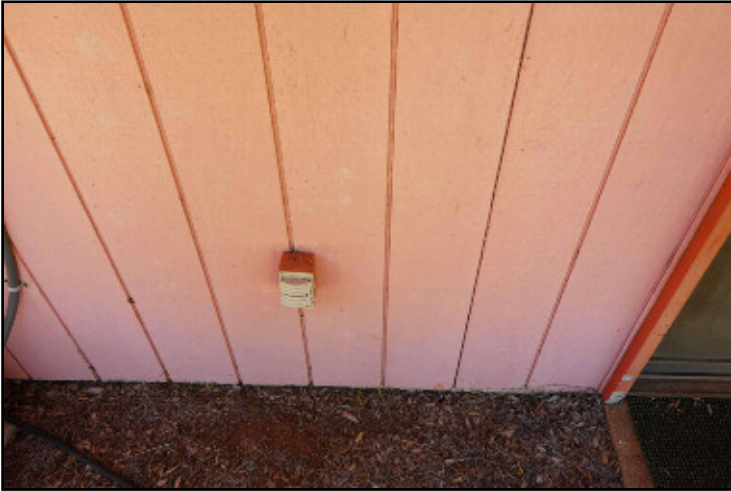
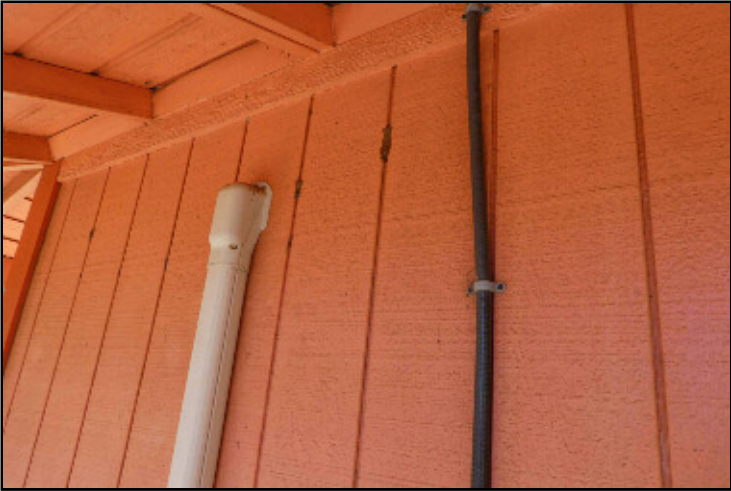
No wood rot or Termite damage observed. Siding is in fair intact condition, and paint is in fair to poor faded condition.

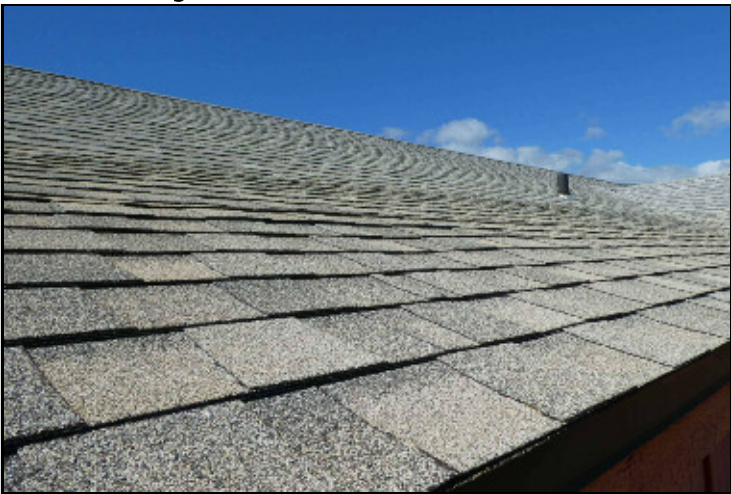
Composition shingle roof was installed 11/2003. Good workmanship noted, drip edging and woven valleys. Fair condition and aging normally.

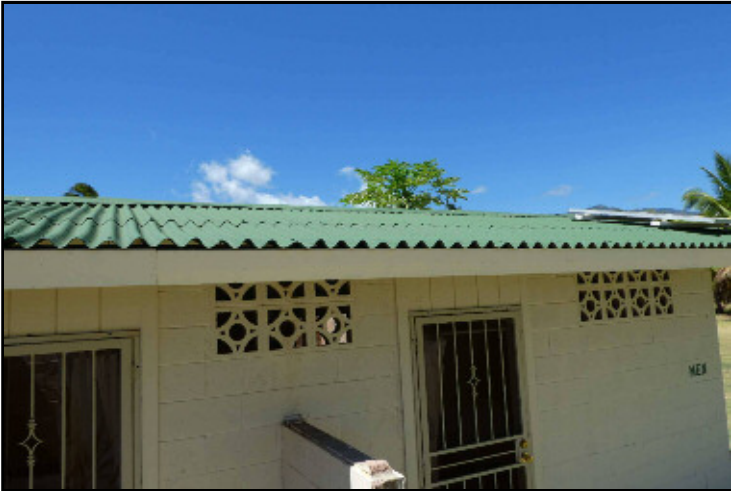
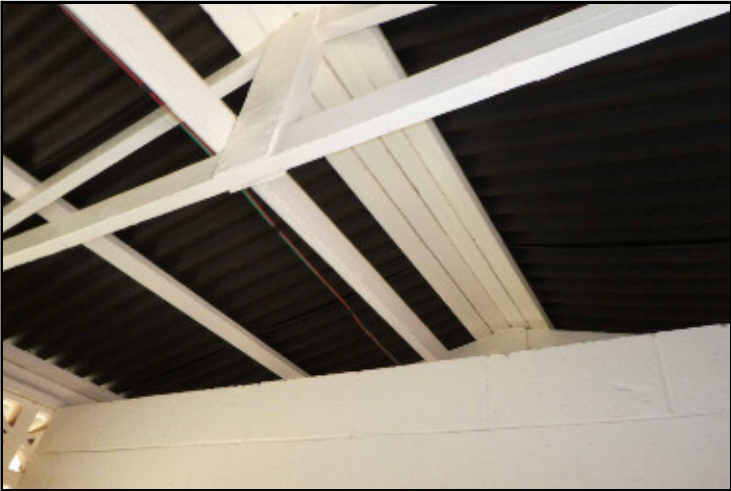
Component:	1110 - Restroom Roof - Replace/Repair	Quantity:	Approx 670 GSF
Location:	Del Monte Park		
Cost Source:	Akamai Reserves Cost Database	Useful Life:	15 Remaining Useful Life:13
Best Case:	\$3,300	\$5.00/GSF; Estimate to replace	
Worst Case:	\$5,300	\$8.00/GSF; Higher estimate to replace

Evaluation: Roof replaced in 2016. New roofing is in good functional condition

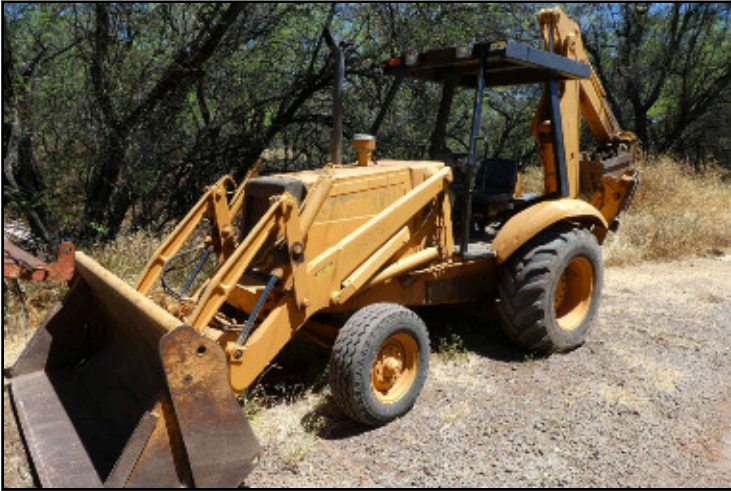
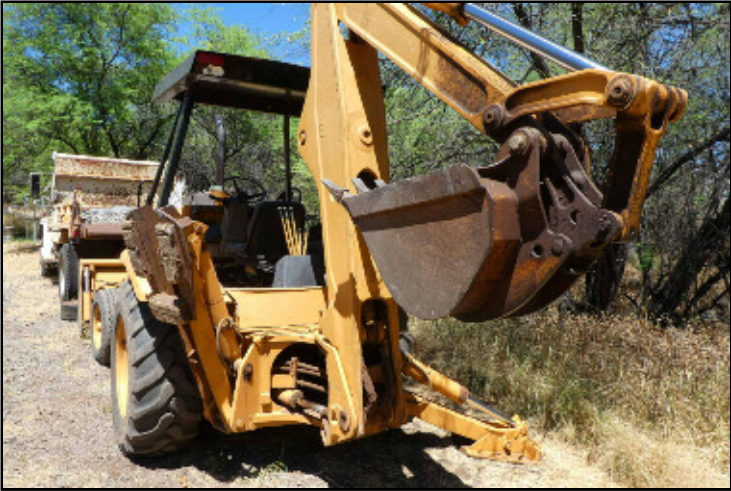
Evaluation: Backhoe was purchased used in 2014. Reported in fair condition. Reported purchase of a new backhoe would be over \$50,000.

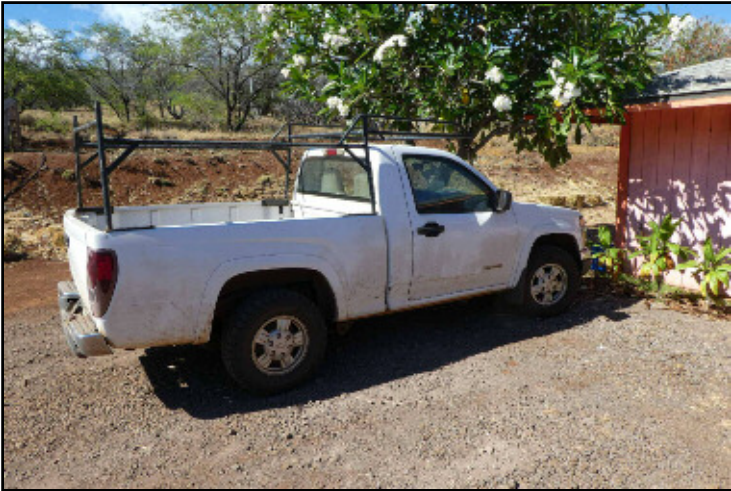
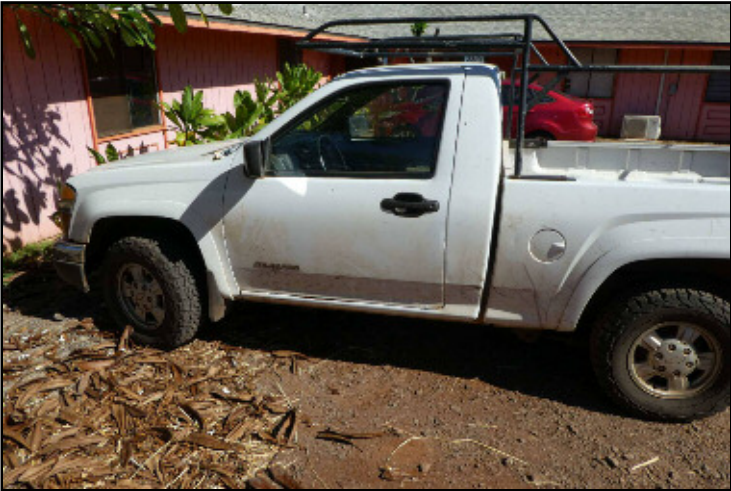
Evaluation: This Chevrolet truck was purchased used and is in fair appearance with no reported problems. Remaining useful life extended based on appearance and maintenance.

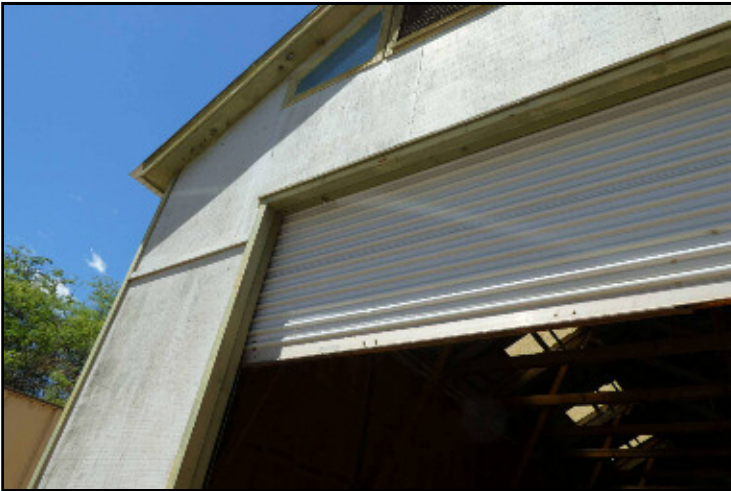
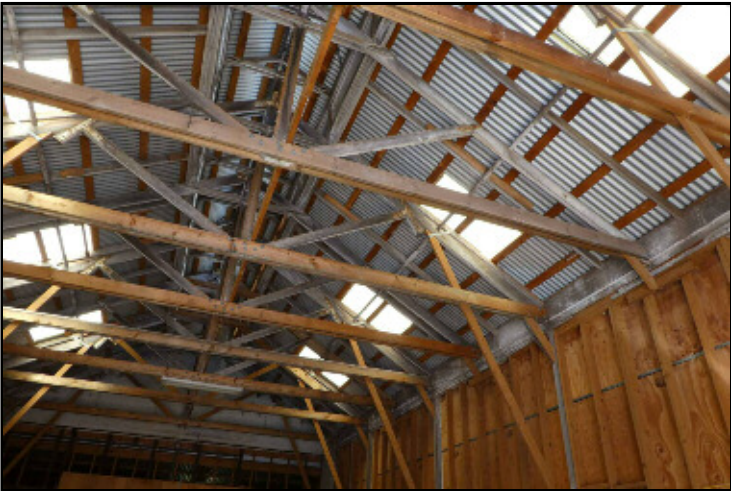
Evaluation: 2 story 1,270 GSF store room with roll up door. T1-11 siding, additional beams and 11 Ft. x 15 Ft.+ roll up door were installed in 1996. Building has a concrete foundation floor with 3 Ft. walls. The building is maintained in fair functional condition.

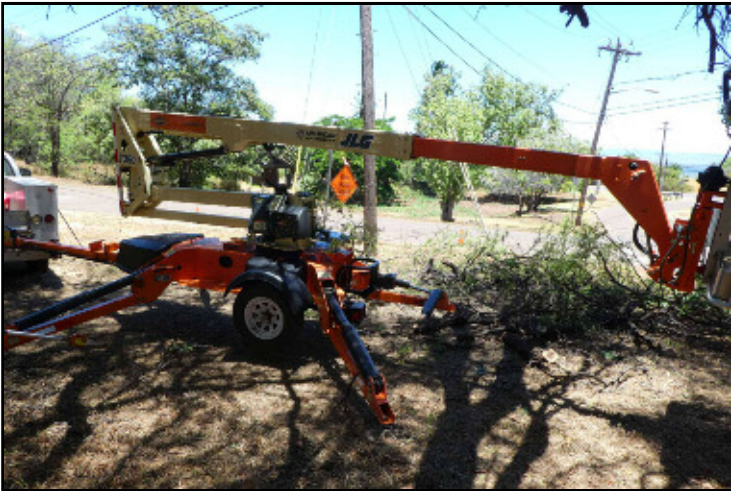
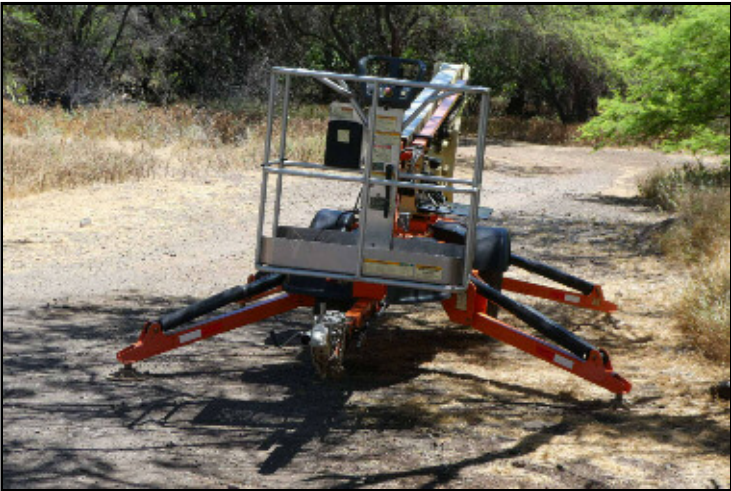
Evaluation: Manlift is in fair functional condition with low usage. Remaining useful life extended based on condition.
