Reserve Study Report

Level I Full With-Site-Visit Study

Kawela Plantation HA

Report	# 3001-3
Prepared	July 24, 2018
Fiscal Year	January 1, 2018 through December 31, 2018
Report Expires	December 31, 2018

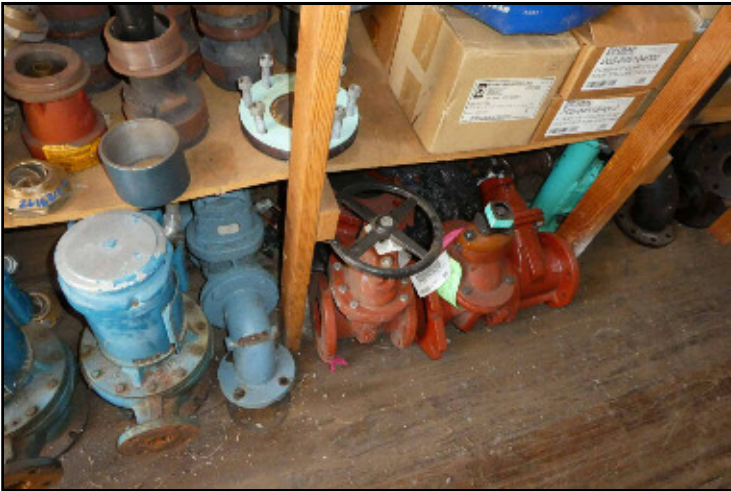
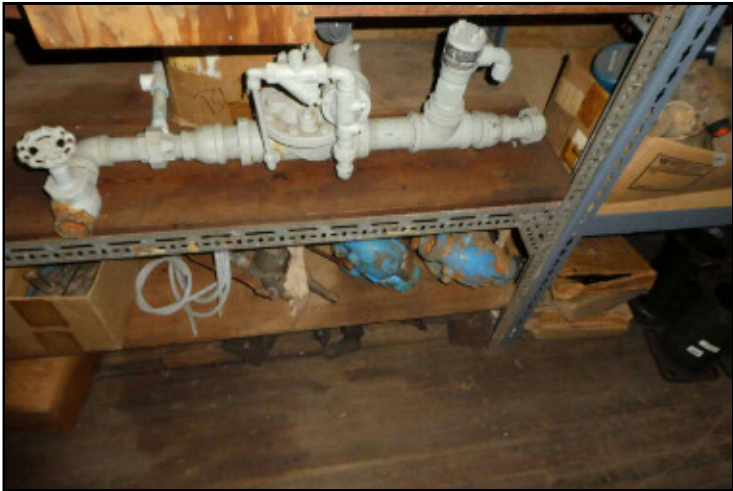
General replacement parts and small repair budget. Requested by board as an annual expense.

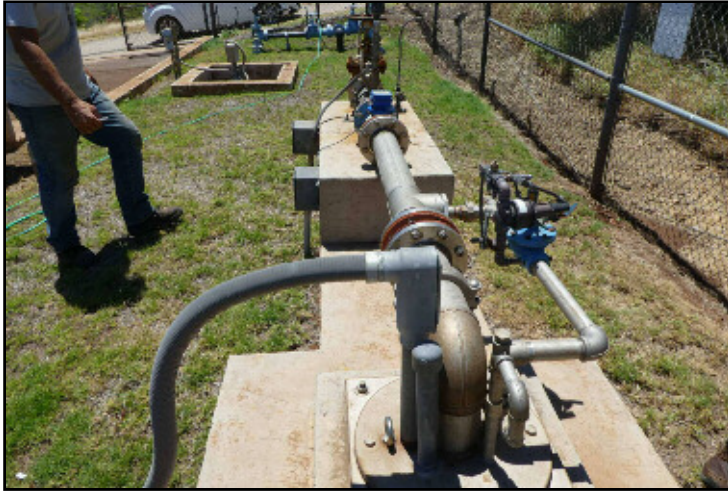
Evaluation: Well casing was replaced in 2009. This is a long life component replacement may be deferred based on future condition.

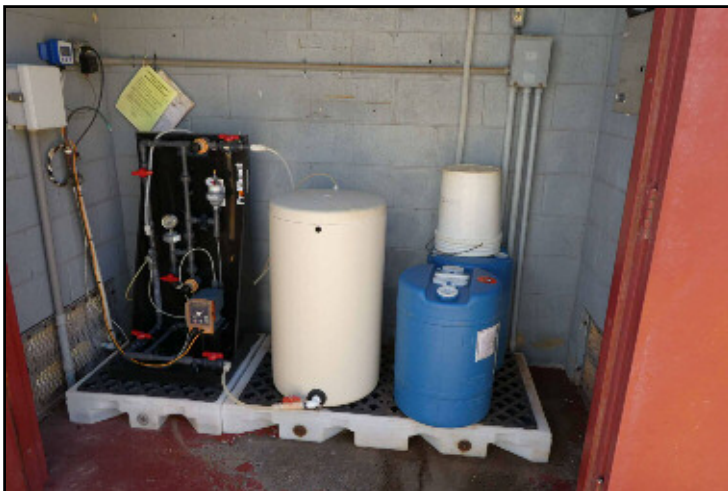
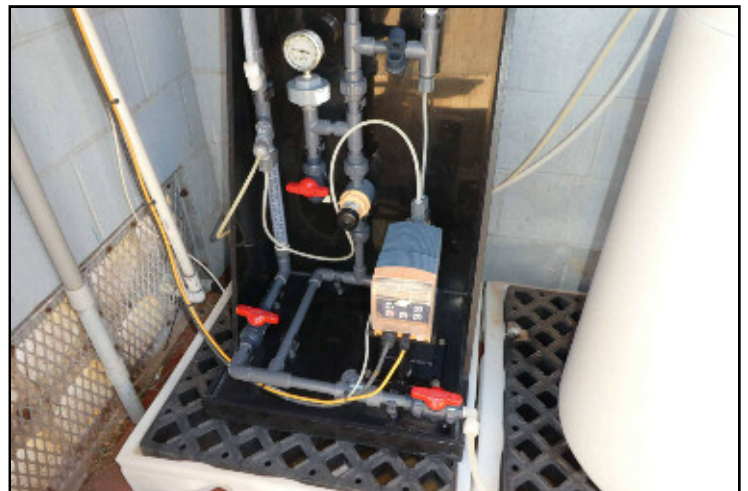
Component: 682 - DW Chlorination System - Replace
Location: Site #1
Cost Source: Client Cost History
Best Case: \$9,000 Estimate to replace
Worst Case: \$11,000 Higher estimate

Evaluation: Water Treatment Building contains fiberglass tanks and small metering pumps. Expect system upgrade in the future. Last upgrade was in 2012.

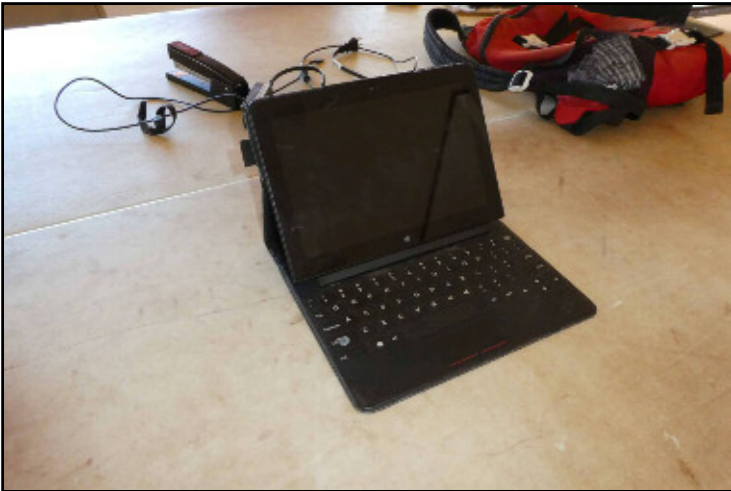
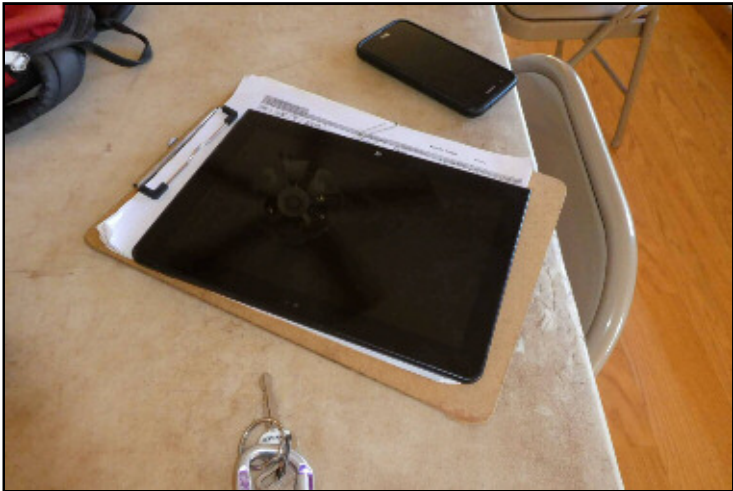
Component:	716 - Field Computers - Replace/Upgrade	Quantity:	(4) Field Computers
Location:	Throughout property		
Cost Source:	Client Cost History	Useful Life:	3 Remaining Useful Life:1
Best Case:	\$4,500	Estimate to replace/upgrade	
Worst Case:	\$4,700	Higher estimate

Evaluation: Windows Surface Pro Tablets are used as field computers. Tablets were replaced in 2016.

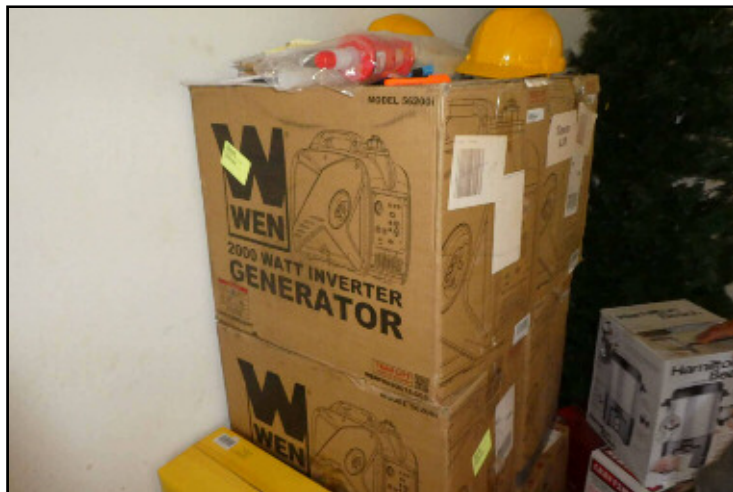
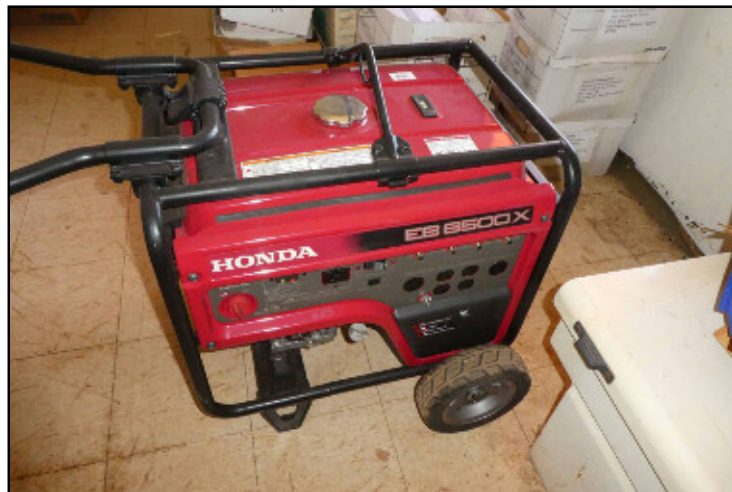
Component: 411 - Generators B/U Power - Replace
Location: Office Building
Cost Source: Client Cost History
Best Case: \$6,000 Estimate to replace
Worst Case: \$7,000 Higher estimate

Evaluation: Honda generator and small portable generators are currently unused. Remaining useful life extended based on lack of use.

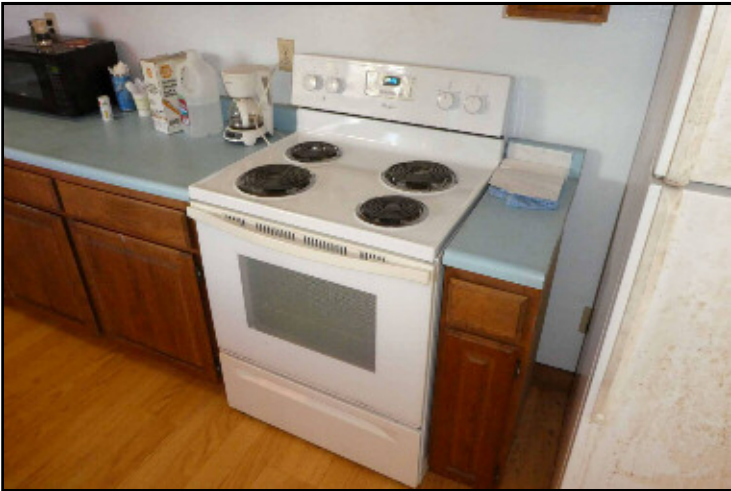
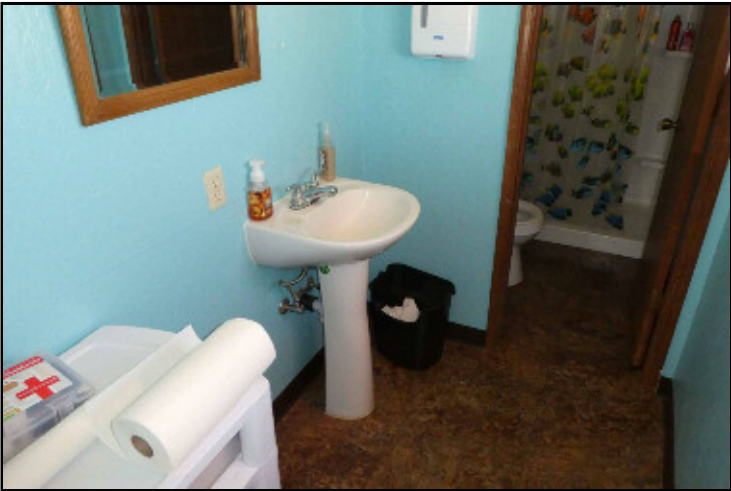
Evaluation: Bathroom has lavatory, toilet and bath tub. Kitchen is in fair condition.

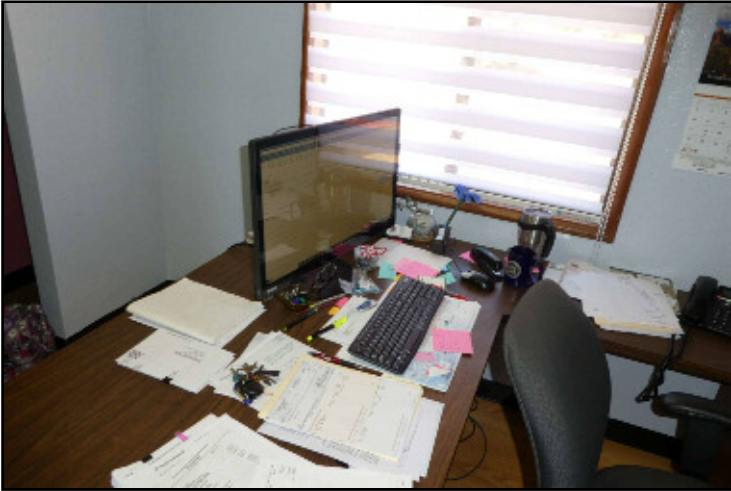
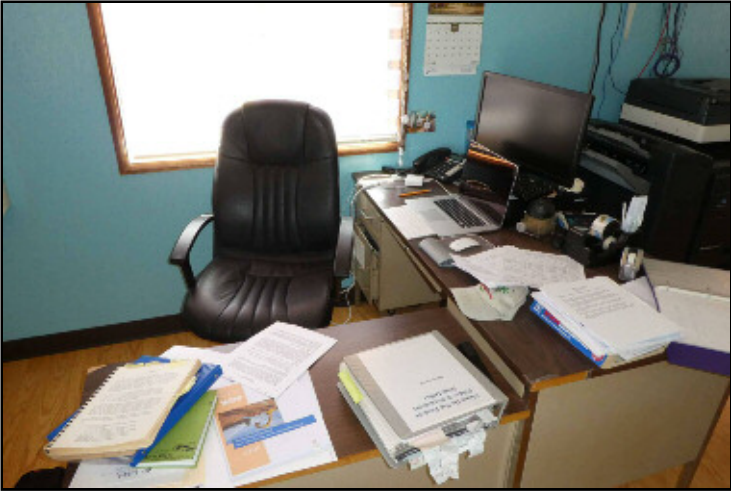
Evaluation: Includes office chairs, desks, and computer equipment. Pieces are in varying condition and ages.

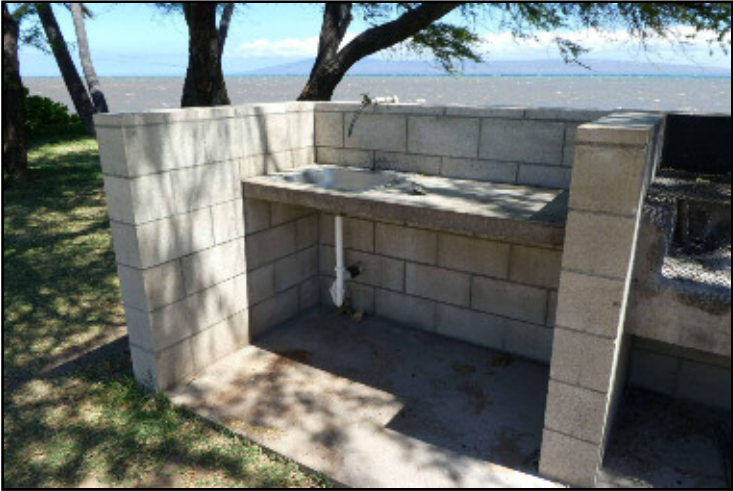
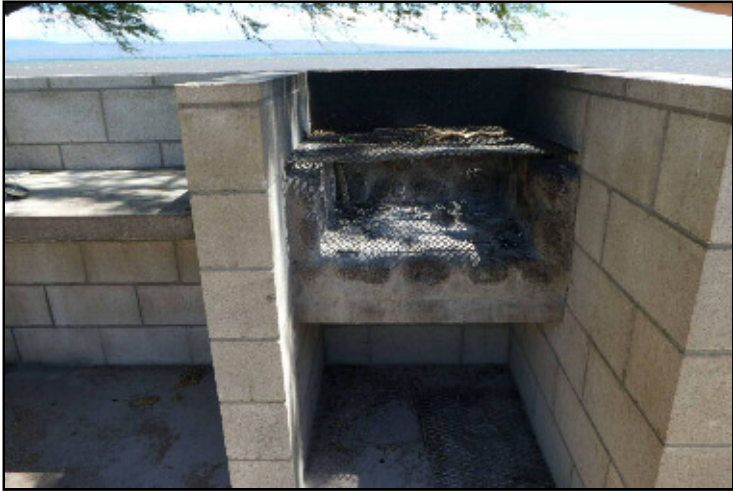
(1) Fire Pit/BBQ

Installed permanent BBQ area in 2016. Future repair and replacement to be handled as needed under the Operating Budget.

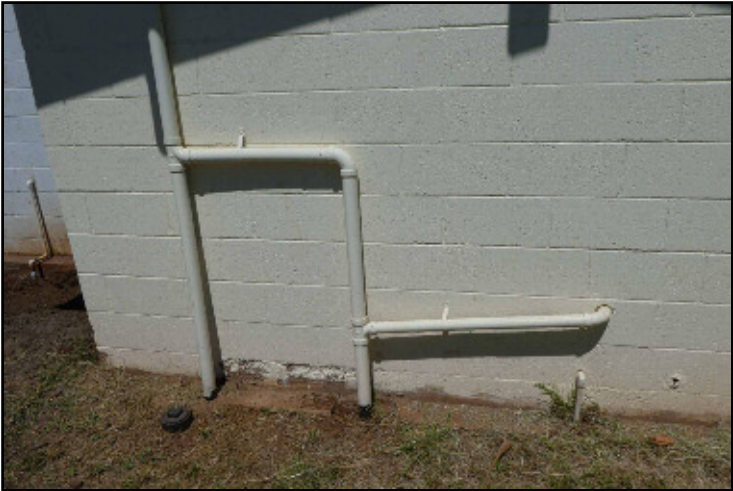
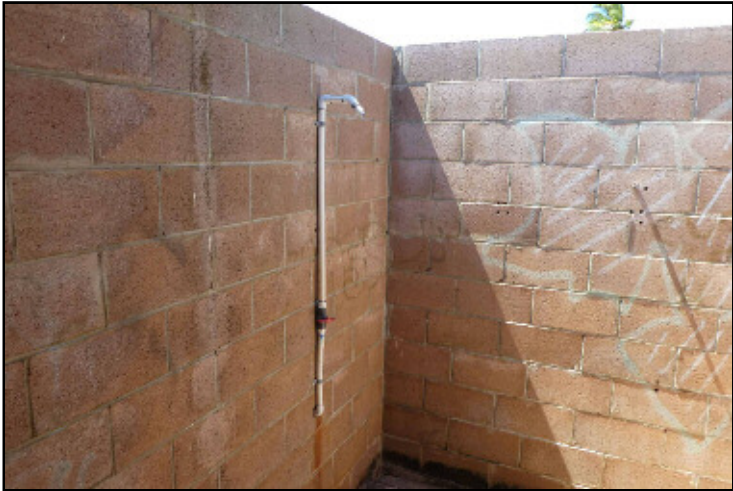
(2) Restrooms

The shower enclosures and both restrooms fixtures, partitions and accessories reported repair work completed in 2017.

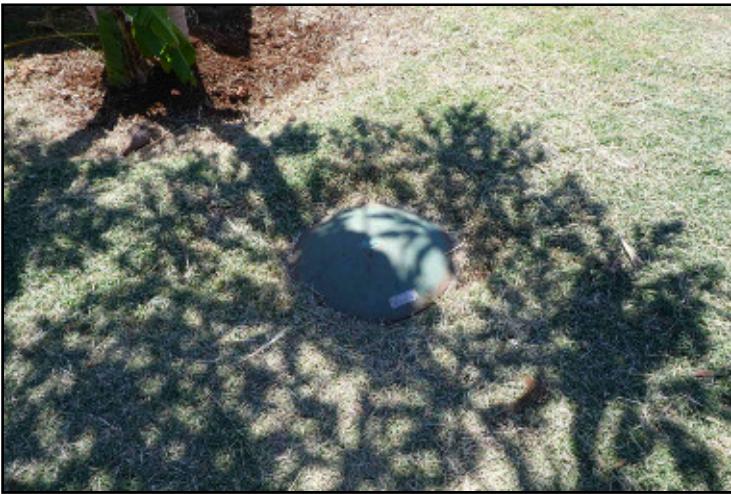
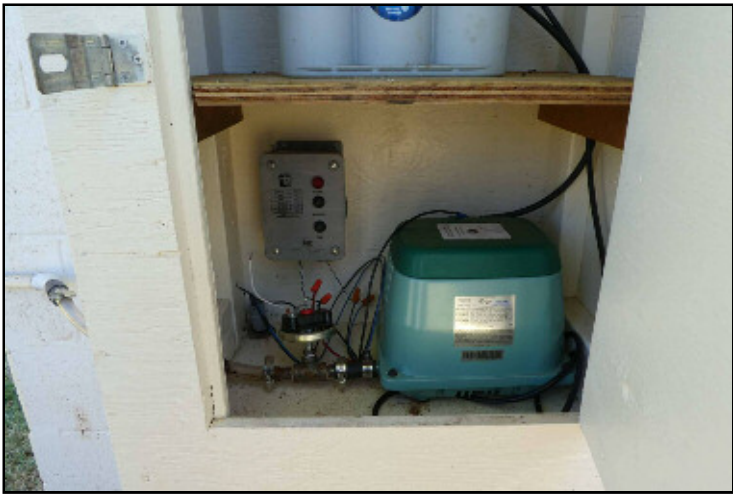
One time expense to install septic system for park restrooms completed in 2017.

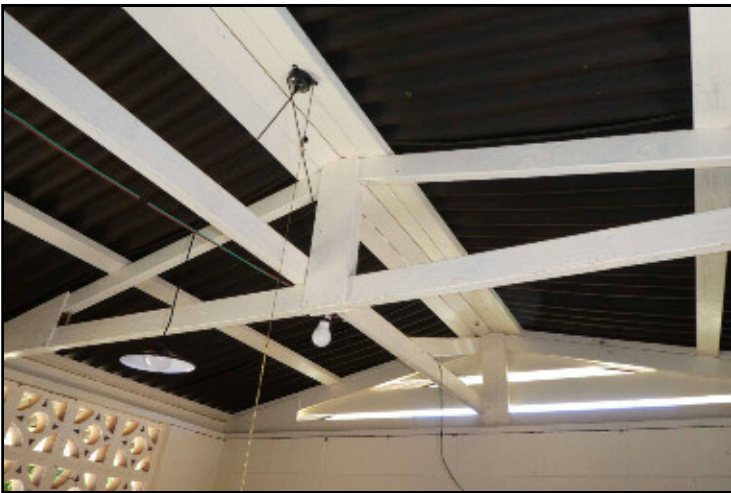
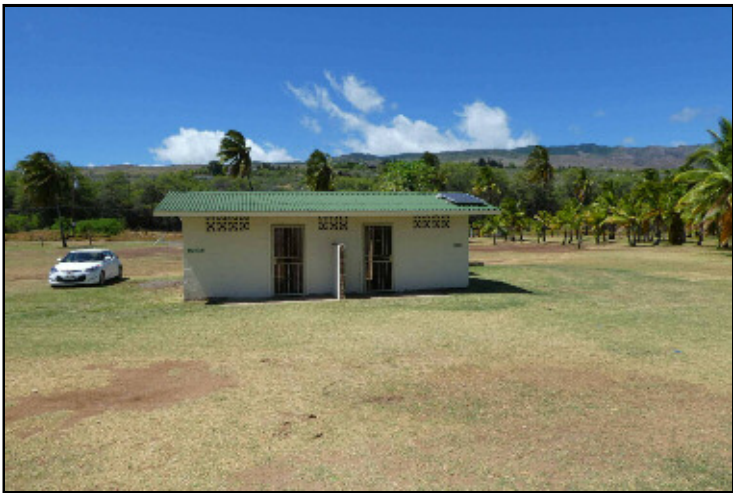
Wood and concrete repairs were performed in 2017.

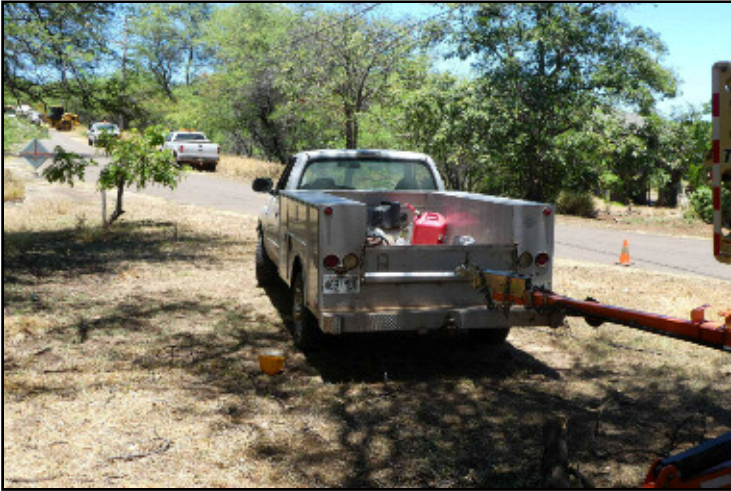
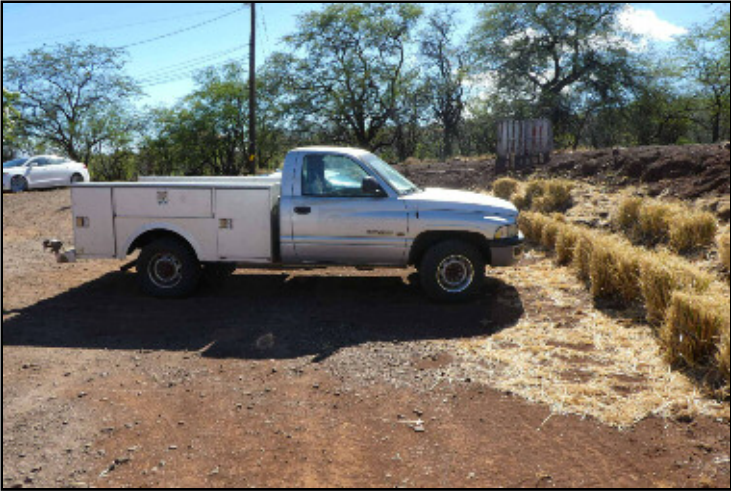
Evaluation: New utility truck purchase is planned for 2018.

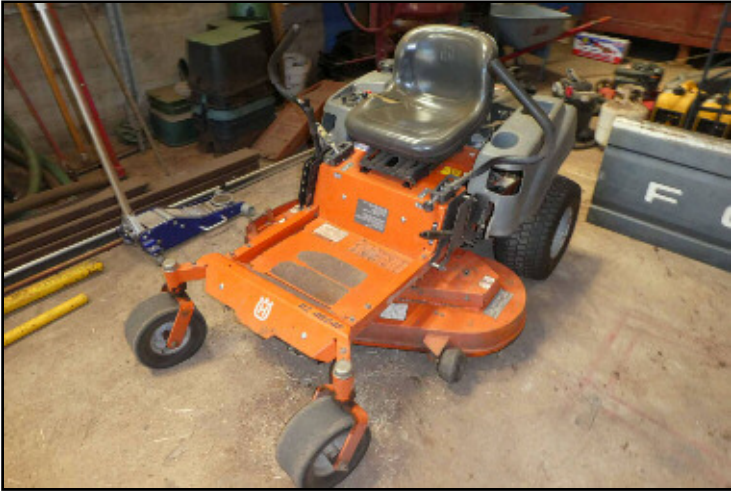
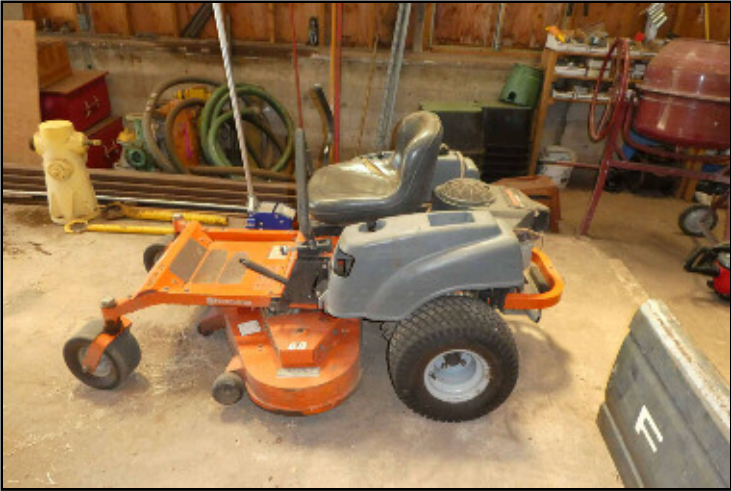
Evaluation: Husqvarna mower is in fair functional condition.

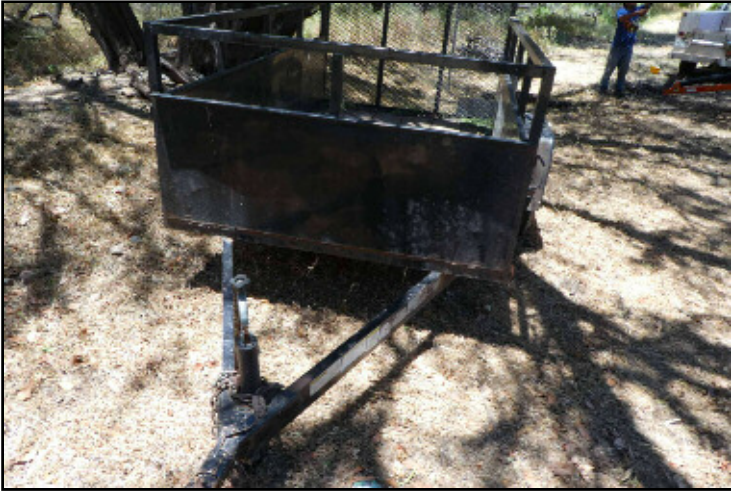
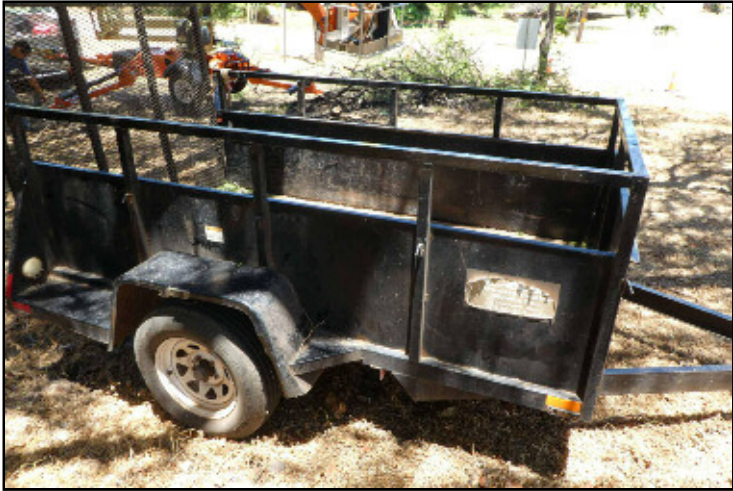
Evaluation: Trailer was purchased new in 2008 and is reported in fair functioning condition.

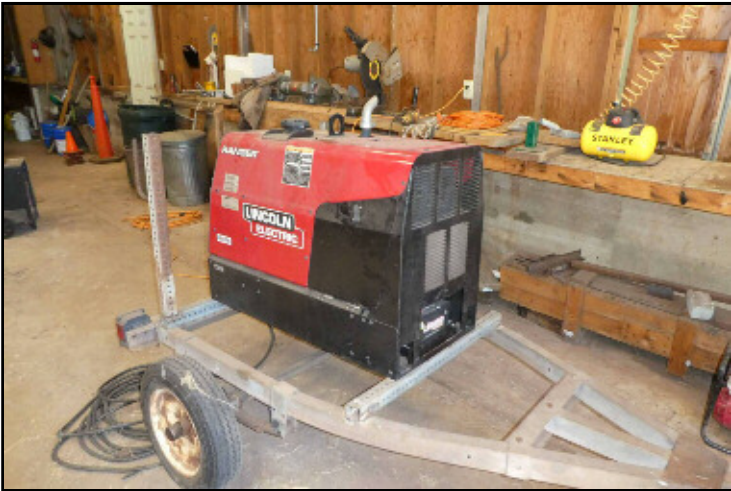
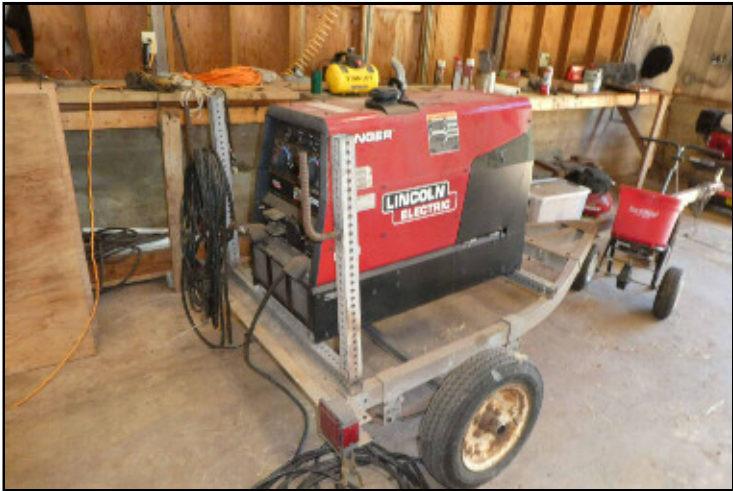
Component: 939 - Generator/Welder Combo - Replace
Location: Storage Building
Cost Source: Client Cost History
Best Case: \$6,000 Estimate to replace
Worst Case: \$6,500 Higher estimate

Evaluation: Portable generator with welder is in fair functional condition.

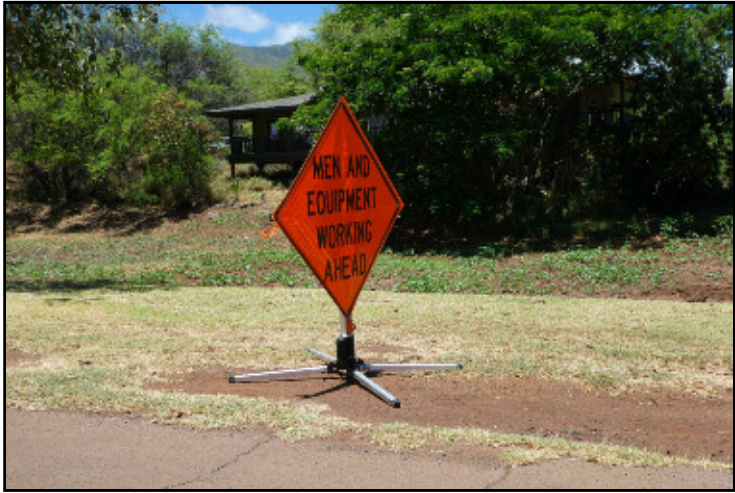
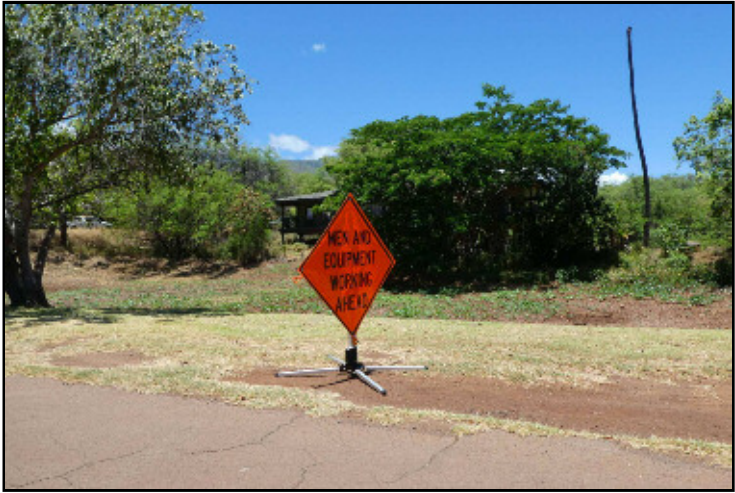
Component:	939 - Traffic Safety Equipment - Replace	Quantity:	Miscellaneous Equipment
Location:	Throughout property		
Cost Source:	Client Cost History	Useful Life:	5 Remaining Useful Life: 3
Best Case:	\$4,400 Estimate to replace equipment		
Worst Case:	\$4,600 Higher estimate

Evaluation: Various road safety signs and cones purchased in 2016.
